# BOISE RIVER ENHANCEMENT NETWORK NOTCH PROJECT

## PROJECT PURPOSE

The purpose of the Notch Habitat Enhancement Project is to improve the riparian condition of an 0.11-acre property, referred to as the “Notch”, owned by the State of Idaho and managed by the Idaho Department of Lands (IDL) along the Boise River.

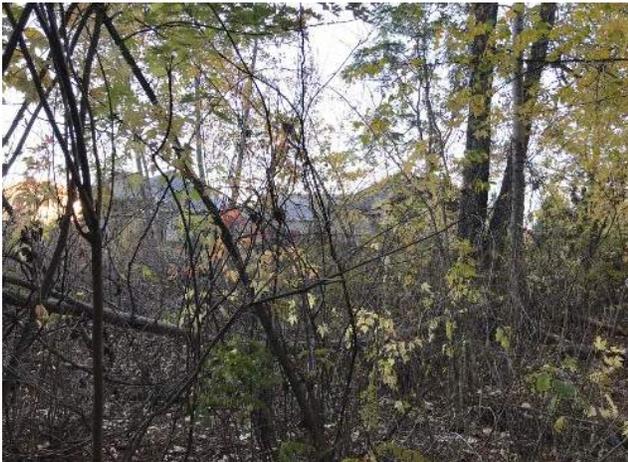
10/21/2020 - Notch project area before project initiation.

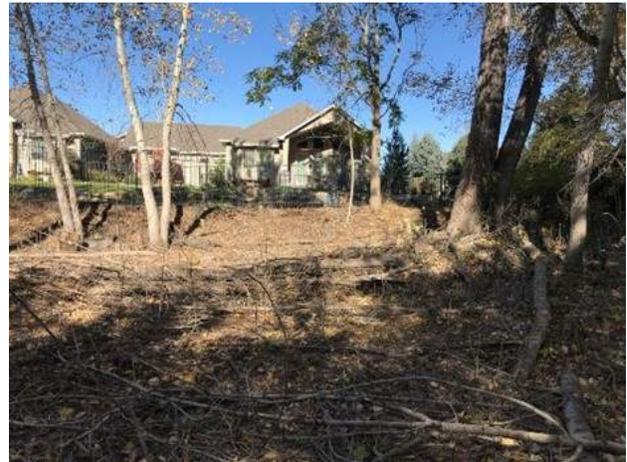
10/21/2020 - Following non-native tree /shrub removal.

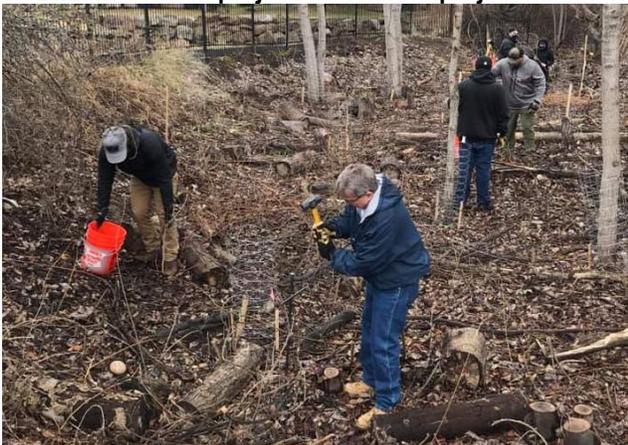
3/19/2021 – Volunteers plant two large bushels of willow stakes and cottonwood seedlings.

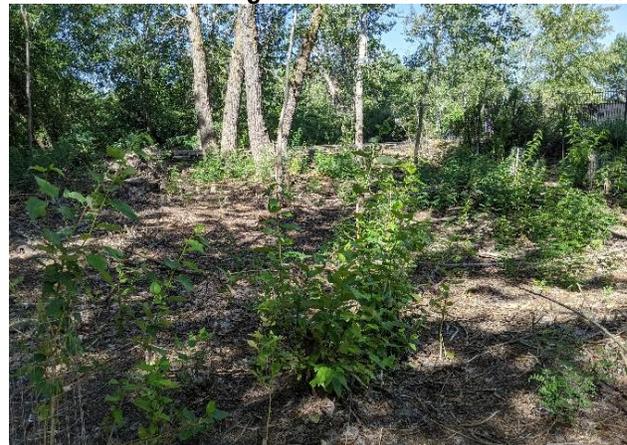
07/01/2021 – Most of the regrowth is of native species. Over 90% of planted species have survived.

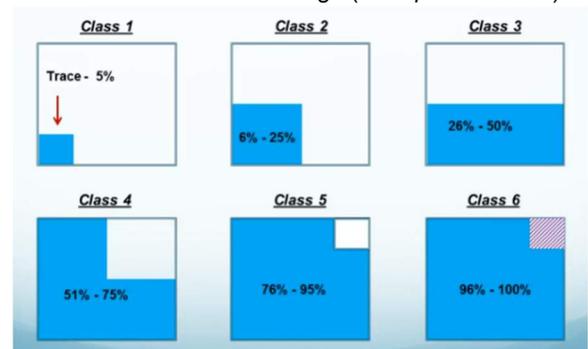
The Daubenmire Cover Class Method is a rapid, semi-quantitative approach that eliminates the need for "precise" estimation of canopy cover. Instead, canopy cover is assigned to one of six (6) classes, as shown to the right.

Within each subplot, the canopy cover class of false indigo was estimated based on the relative proportion of the subplot that is covered by the plant(s).
